# **Georgetown Canyon, Right Fork Mine Preliminary Assessment Report Addendum**

Bear Lake County  
State of Idaho

**Department of Environmental Quality**

August 2008

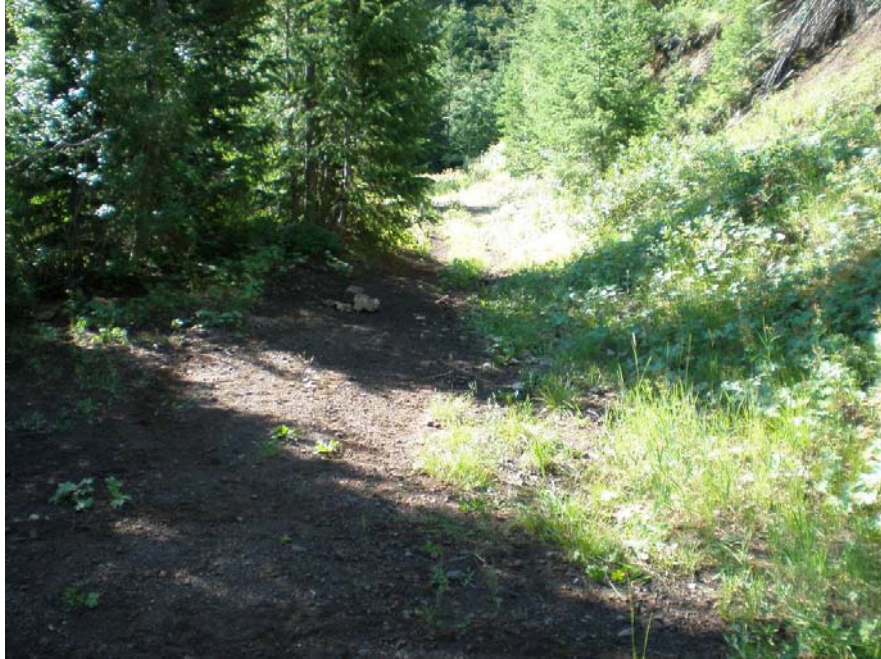
*Photo 1: The road leading to the Right Fork mine is narrow and overgrown yet still passable with four wheel drive and all-terrain vehicles during dryer months. There appears to be limited human activity and cattle grazing in the area.*

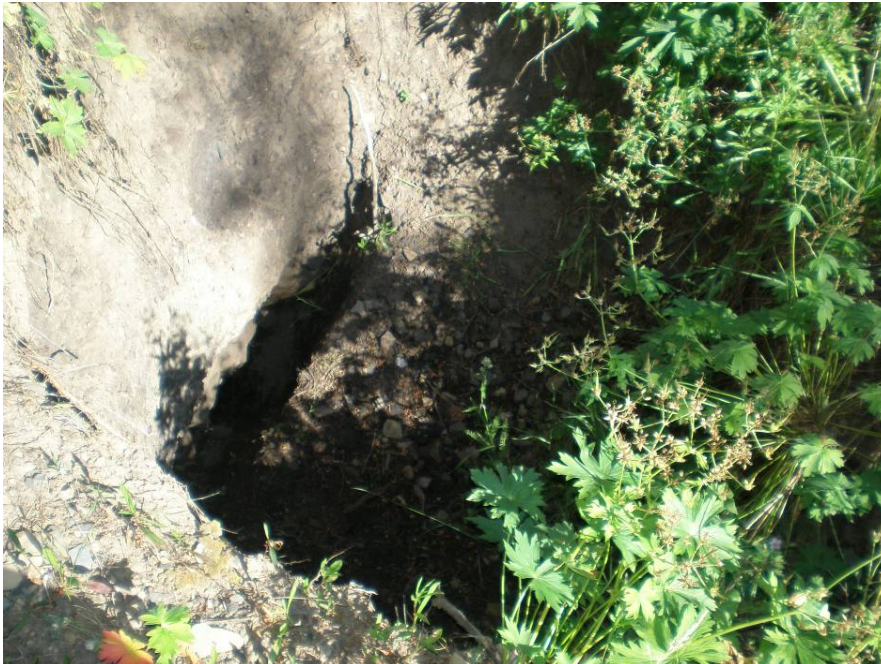
The mine shaft, located at the base of the access road cut, is collapsed, yet remains identifiable and has a small opening that may continue down into the mine tunnel. The shaft does not appear to pose any environmental hazards. See photograph 2 in the Appendix.

*Photo 2: Collapsed adit to the Georgetown Canyon, Right Fork Mine. No environmental concerns are associated with the adit. A small opening (approximately 3 feet x 3 feet) still remains in the adit that may be a hazard to a child.*

- Complete closure of shaft. This may be accomplished in a couple of hours, by one or two individuals with shovels.
- No further actions at this site would be necessary a disturbance of the waste rock dumps or roads at the mine would likely be detrimental to the area.

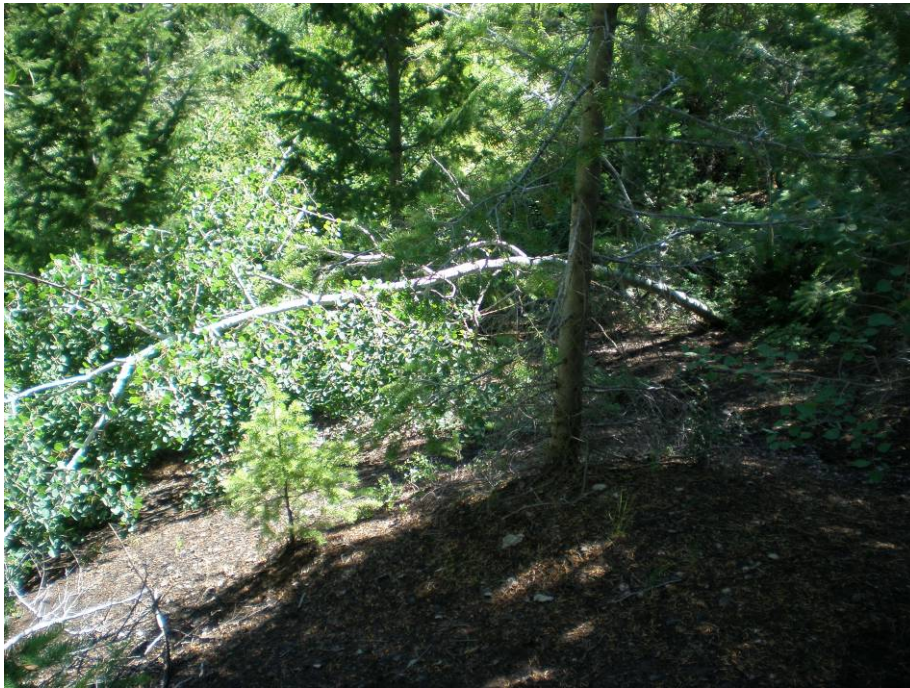
The main waste rock dump is located about 50 feet southeast of the shaft and is not evident from the access road or the Right Fork Canyon Road. Vegetation and vegetative debris are abundant on the dump with little signs of erosion. A log cabin is located on the southwestern edge of the dump (Photos 3 and 4). The main dump is approximately 400 square feet in area, 20 feet high and estimated to contain 200 to 300 cubic yards of waste rock. While the analysis of soil samples collected in 2002 (DEQ, 2004a) from and directly below this dump resulted in elevated levels of cadmium, chromium, nickel, selenium, vanadium, and zinc; the impacted area below the main waste rock dump appears to be small with little migration of darker waste materials. Disturbance of this dump is likely to cause more movement and erosion of waste rock than leaving the area in its current state.

*Photo 3: The waste rock dump located east of the cabin and north of the adit is not visible from below the mine due to the abundance of fir and aspen trees in the area. The dump is 400 square feet in area, 20 feet high and estimated to contain 200 to 300 cubic yards of waste rock.*

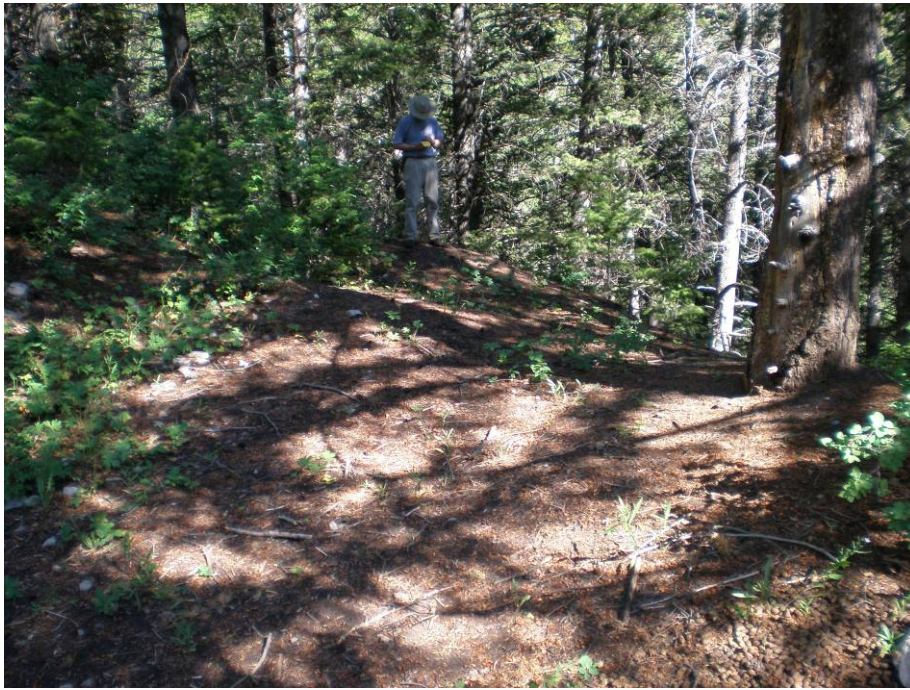
A second and smaller waste rock dump is located at the terminus of the access road, approximately 40 feet west of the mine shaft. This dump is also well vegetated with abundant signs of wildlife usage (Photo 5).

*Photo 5: A Small waste rock dump is located at the end of the mine access road, approximately 40 feet west of the shaft.  
The dump is well vegetated with signs of animal use.*
